"Landslide in Chittagong: Causes, Effects & Remedies"

Urban Development Directorate,
Ministry of Housing & Public Works,
September, 2010.

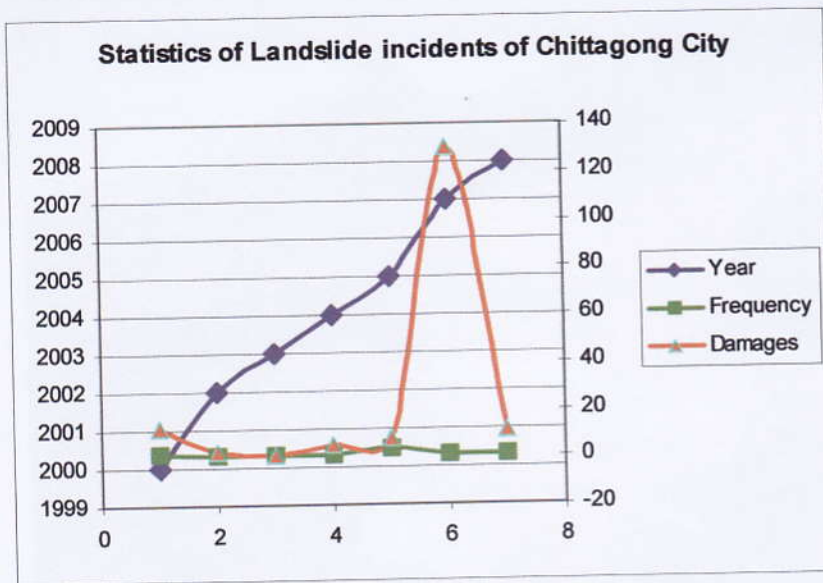
Fig-9: Statistics of Landslide incidents in Chittagong City.

The historical background of landslide incidents in Chittagong City and its surrounding areas is very alarming. Statistics shows that in 2000, there happened two landslides in Chittagong city in two times, which killed 13 people. But there happened no landslide in 2001. From 2002 to 2004 there happened single landslide in every year and killed 3, 1 and 5 people respectively. On the contrary, in 2005, it happened four several landslides in Chittagong city which caused death of 8 people. In 2007, the most massive landslides took place at seven points in Chittagong City and killed 130 people, which is the highest in landslide incident history of Bangladesh. After this huge damage 11 people were died by landslide just next year (2008) in Chittagong City.

No.	Year	Frequency	Damages
1	2000	2	13
2	2002	1	3
3	2003	1	1
4	2004	1	5
5	2005	4	8
6	2007	1	130
7	2008	1	11

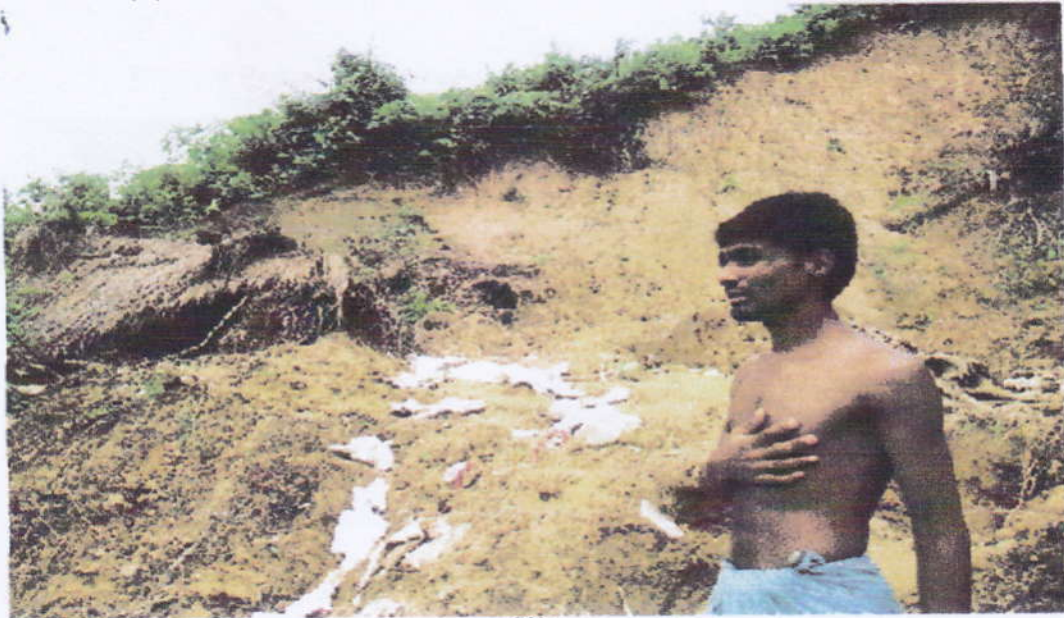
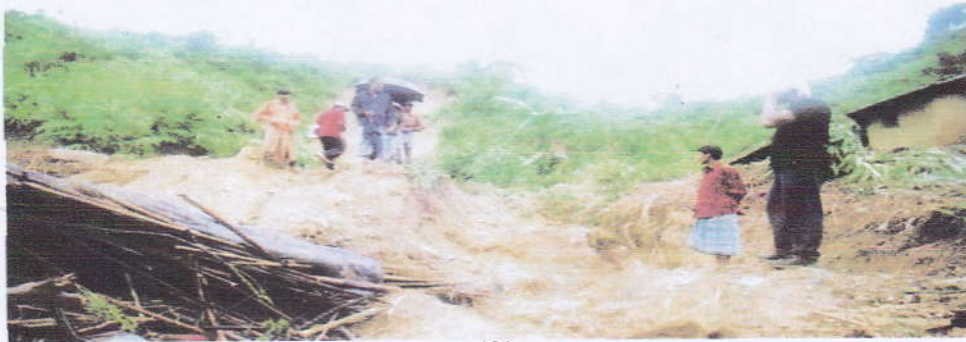
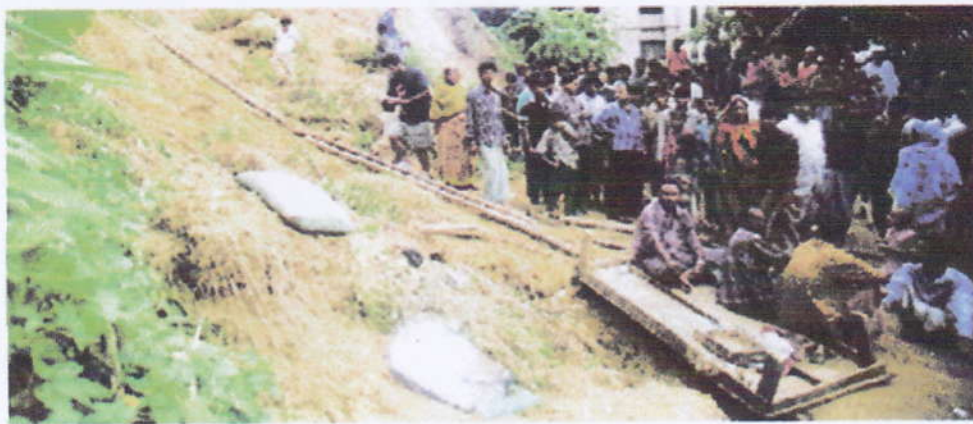
Picture (A): Immediate After Landslide Incident in Chittagong on 11 June 2007

Chittagong the Southeastern Divisional city of Bangladesh is the most vulnerable for landslide. On 11 June 2007, at the very early morning the city of Chittagong experienced a deadly landslide with massive casualties. Motijharna, Power colony, Kushumbag, Dhaper parh, Shaheed Minar area of Chittagong University, Lebubagan and Kachchaghona of Chittagong Cantonment area were badly affected by landslide. More than 130 people dead including women and children adding 213 wounded. Extremely heavy rainfall counting as long as 267 mm in 24 hours was observed on the day causing water logging within the city area, submerging ground floors of about 500 buildings of city's commercial area Agrabad landslide and Flash Flood bound to homeless a total of about 5072 families and affected another 1.5 million people in Chittagong region. Army, police, fire fighter, NGO activists and other volunteers drove rescue operation. Rescuing the affected people was under challenge because of bad weather, especially heavy rainfall and flooding with an additional of adequate rescue equipments. Rescue operation was observed very slow because of lack of technical knowledge, poor co-ordination and absence of landslide contingency plan professional rescue coordination was not in place.

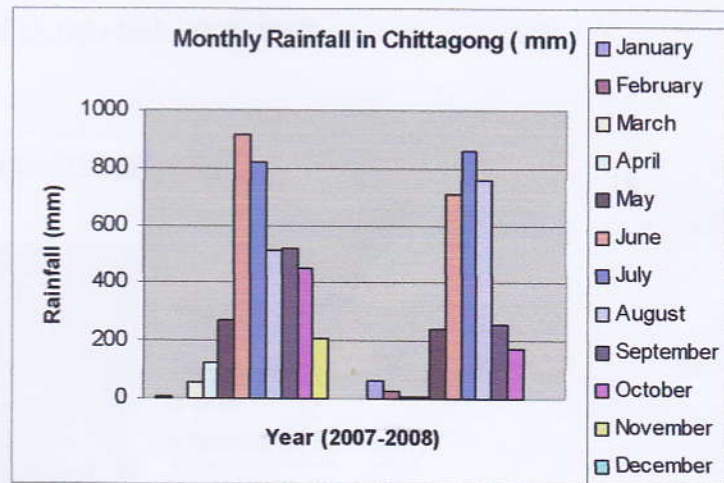
Fig-2: Monthly Rainfall in Chittagong (mm)

Month	Rainfall (mm)	
	Year	
	2007	2008
January	005	063
February	000	030
March	057	006
April	128	004
May	271	244
June	917	707
July	816	859
August	516	759
September	523	255
October	450	175
November	207	000
December	000	000
Total	3845	3092

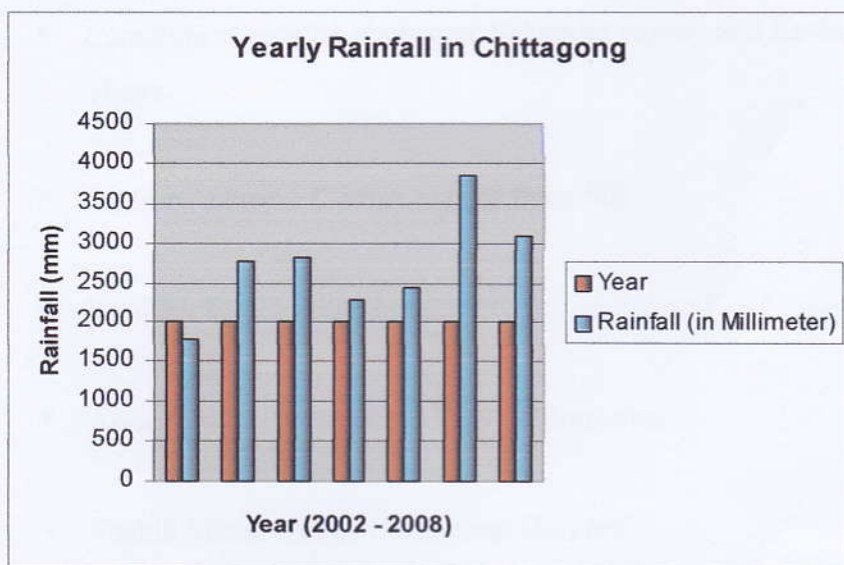
Fig-3: Yearly Rainfall in Chittagong

Year	Rainfall (in Millimeter)
2002	1789
2003	2769
2004	2819
2005	2283
2006	2443
2007	3845
2008	3092
